REPORT FGT-2999

MODEL B-58

DATE February 11, 1963

MATERIAL - BRAZED HONEYCOMB PANELS -
STRUCTURAL REPAIR - EVALUATION OF -

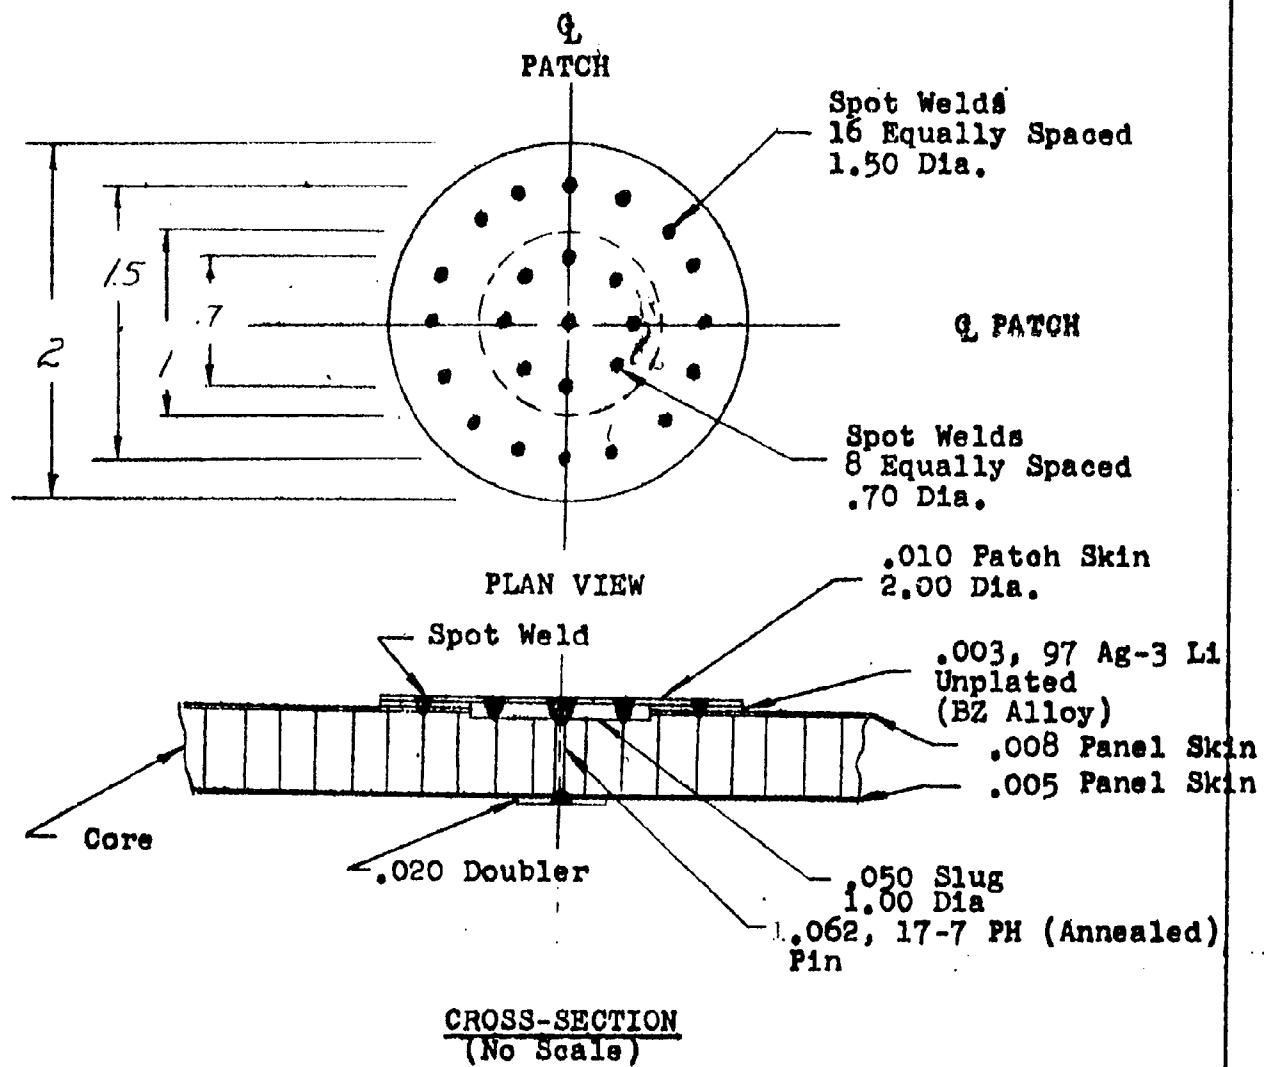
FIGURE 12

The configuration of the TIG spot welded patch is shown in Figure 12. It can be seen that in addition to the sixteen spot welds attaching the patch to the outer skin, there is a pin passing through the panel which is spot welded to a doubler on the back skin. In a standard repair the back skin is not disturbed other than the spot welding of the pin and doubler.

NOTES: Specimens 1 thru 4
Tig Spot Welded Patch
Tig Spot Welds Thru 97 Ag-3 Li Alloy, Patch Skin to
Panel Skin
Specimen 5
Indirect Resistance Spot Braze Patch
Same Configuration as above only Pin and
Doubler Omitted

The normal repair procedure, as outlined in FPS-0085, was followed for panel specimens numbers 1, 2 and 3. Panel specimen number 4 was an experimental repair in which the patch assembly procedures were varied. The patch was shimmed and tension loading of the pin was relieved. The back skin doubler was welded to the pin before assembly with patch. As a result there was no weld bead penetration of the bottom skin. Panel specimen number 5 was completely different from the other four specimens in that the patch was indirect resistance spot brazed to the skin. The same technique was used for attaching the patch to the slug and core. The 97Ag-3Li braze alloy was not only placed between the patch and the panel skin but between the patch and the slug, and the slug and the core. No pin or back skin doubler was used. The system of indirect resistance spot brazing involved placing two copper electrodes in close proximity^{*} to the skin area to be brazed. One electrode had more contact area so that the heat was concentrated at the smaller electrode, where it was desired to spot braze. Because of the variations in assembly and joining of the repair patches in panel specimens numbers 4 and 5, test results obtained were not considered to be representative of properly repaired panels.
